South Bastion Ex- TOC H Site

Statement of Significance

Prepared by The Gibraltar Heritage Trust
20th March 2012

UPDATED: 12th January 2017

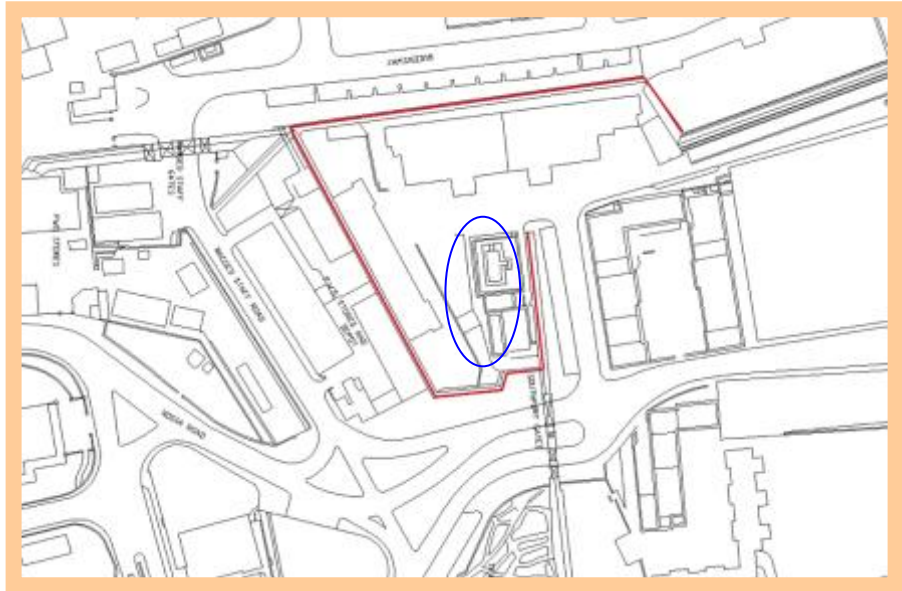
Fig 1: Site plan

Located at the Southern end of Main Street the Site is located within the boundaries of the South Bastion (marked in red Fig 1). This report will focus on the area marked in blue, that being the site of the Ex TOC H Hostel.

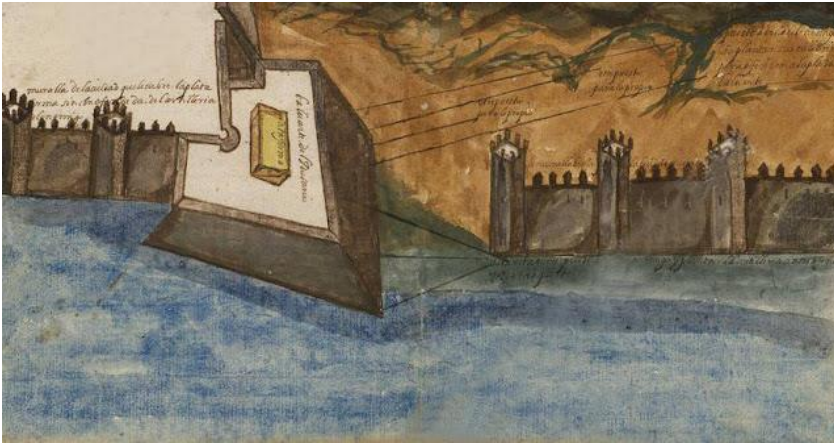
Fig 2: 1597 watercolour. Artist unknown. Shows a gun platform and little else

A number of construction phases and periods can be observed in the South Bastion, marking its evolution and adaptation as military technologies change over the centuries. Its evolution can be observed in contemporary watercolours and technical drawings.

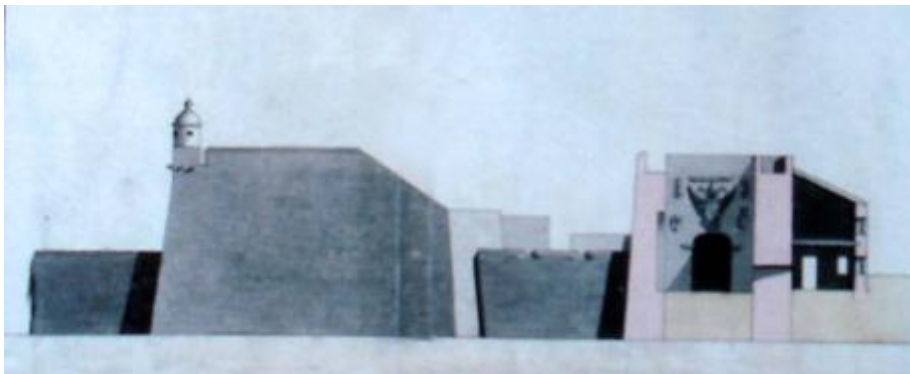
Fig 5: 1700, South Bastion and Southport Gate showing the *bartizan* or *guerite*, a small watchtower, at the SW corner of the bastion.

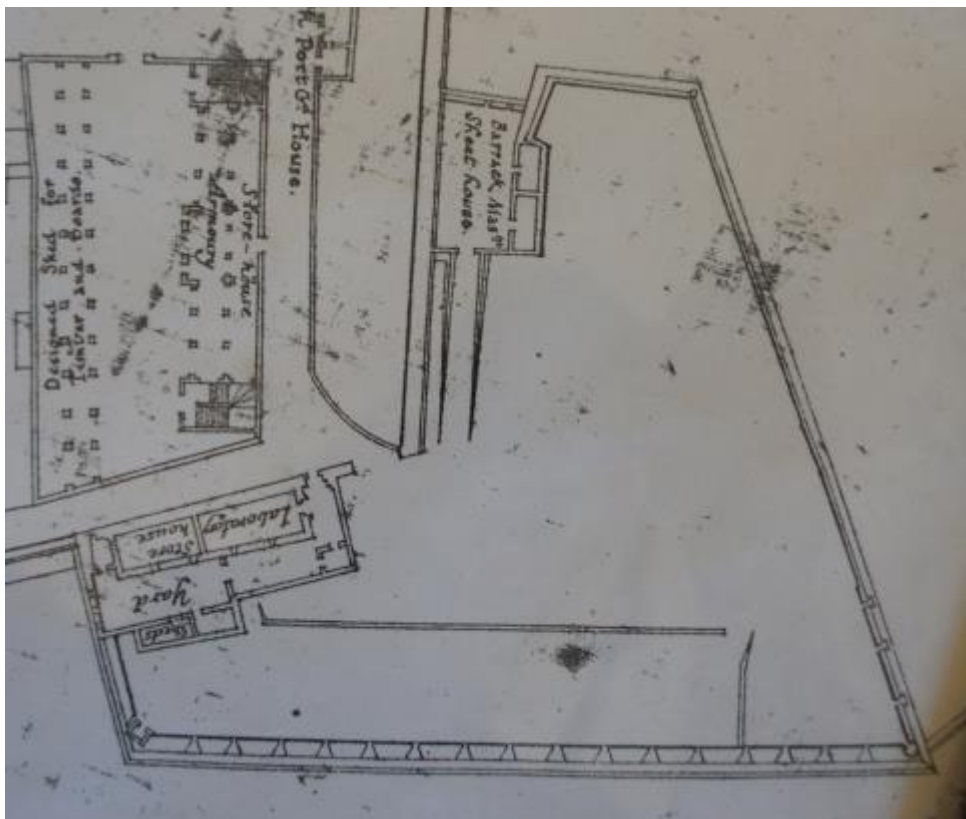
Fig 6: South Bastion in 1753, just before Tyrwley and Rainsford's improvements. Note the existence of the Barrack Master's Sheet House

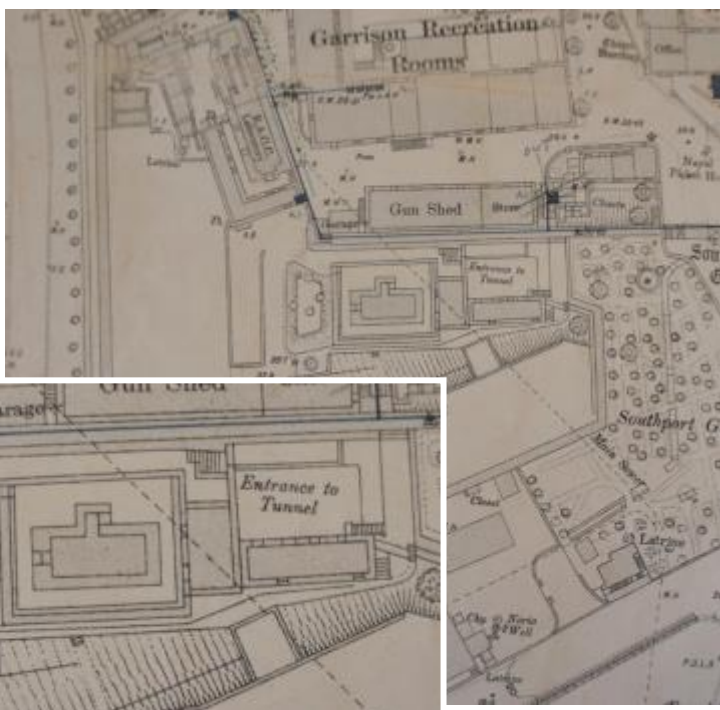
Fig 7: 1869 ordnance survey showing powder magazine and other buildings on the site.

All connecting accretions between the magazine and the barrack master's sheet house should be removed as well as internal 'garden' walls. However, some of the walls will have been the boundary/blast wall for the magazine (see fig 7) and should be kept and used as a feature.

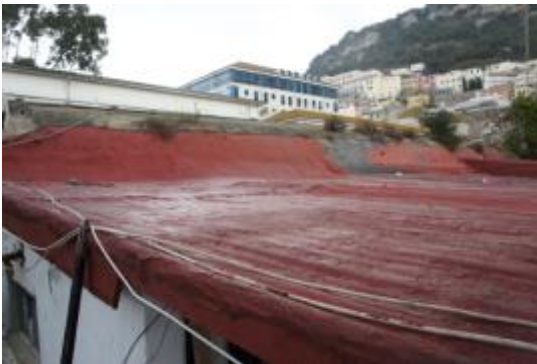
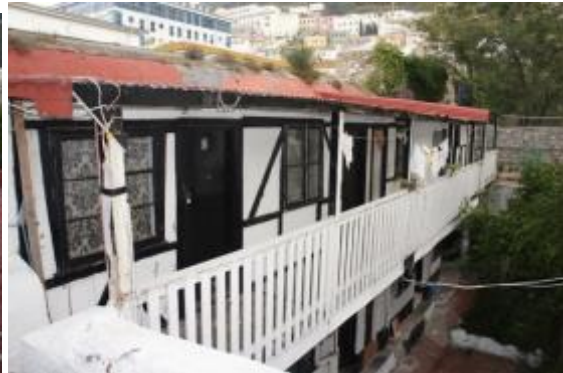
Toc H Hostel abutting the walls

The Toc H building itself is in a very poor state and of little historic value within the context of the battery. There would be no objections to its demolition. The building itself abuts the bastion wall so care should be taken in its demolition not to damage it further.

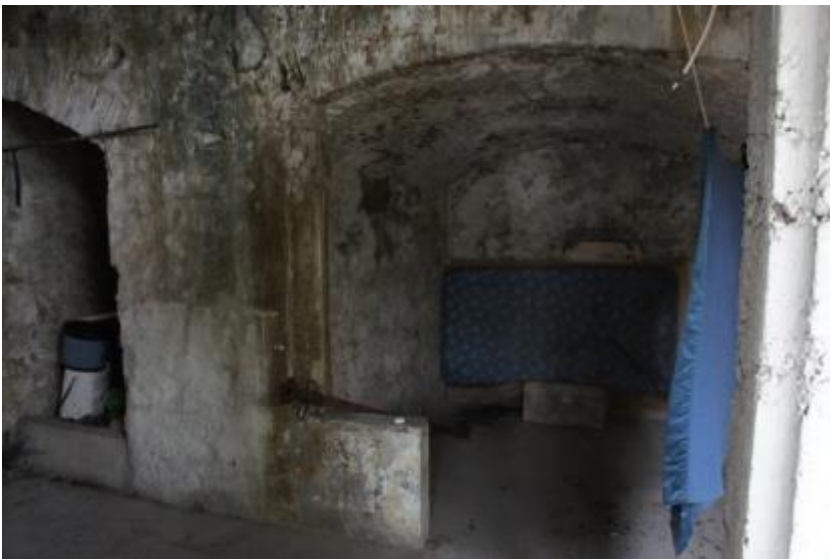
Interior of embrasures facing east

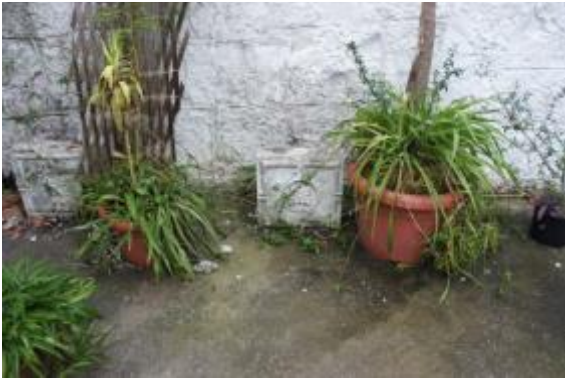
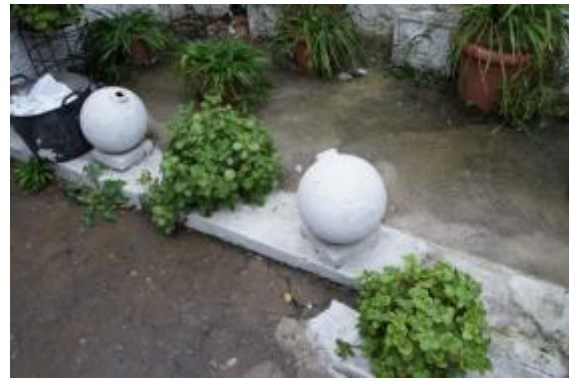
Items of mobile heritage that should be stored and then reused on site

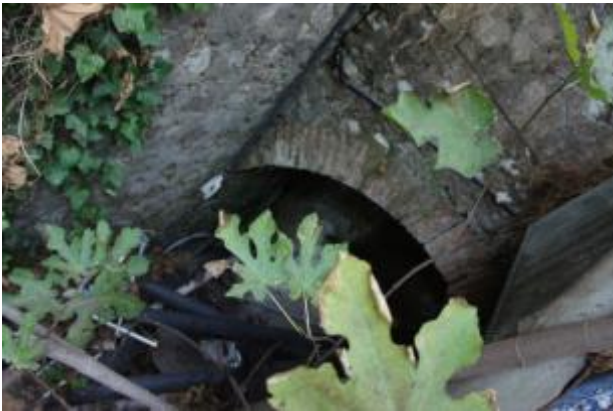
Existence of Tunnel under the site should be noted (see fig 7)
